You will find enclosed Service Bulletin S04HP regarding the Hendrickson steering arm assembly on your Blue Bird "Vision" (BBCV) model buses.

May 20, 2004  
Service Bulletin S04HP  
Page 2

**Service Bulletin S04HP BBCV Hendrickson Steering Arm Inspection/Replacement**

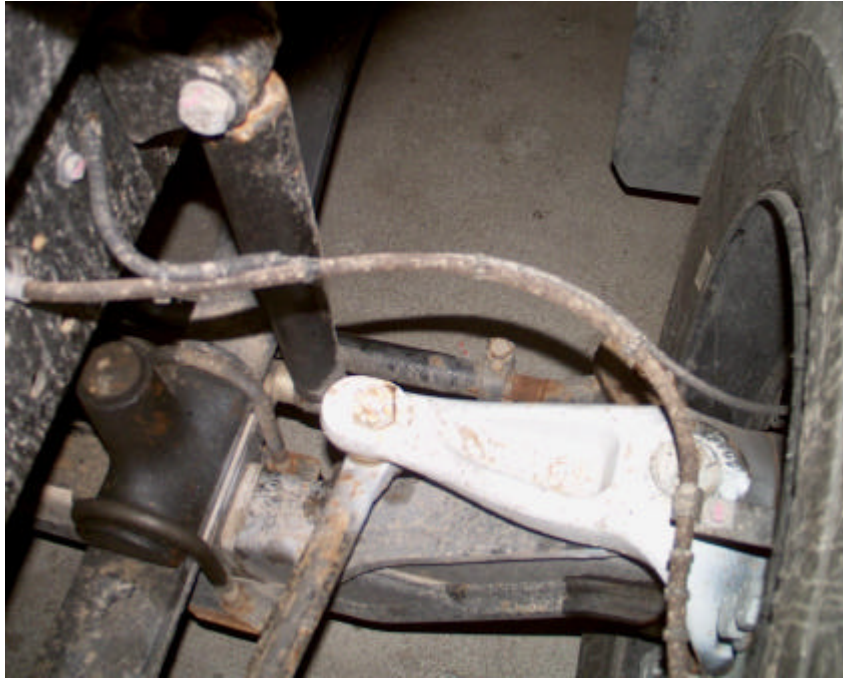
Correct Steering Arm Assembly shown above.  
Note: White paint indicates control arm has been inspected or replaced.

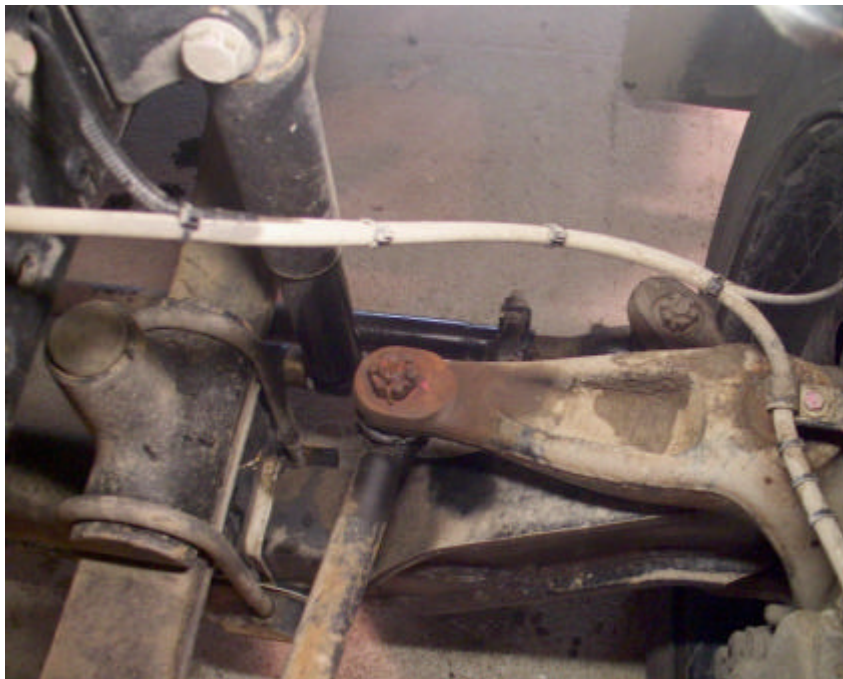
This bulletin addresses certain Hendrickson steering arm assemblies that were not manufactured to Hendrickson's engineering specifications. The incorrect steering arm reduces the designed left turn angle and corresponding turning radius. With an incorrect steering arm, the drag link may contact the front bumper during a maximum left turn if the front bumper is adjusted to the rear most position. This contact does not affect steering control.

Incorrect Steering Arm Assembly  
Note proximity of drag link hole location to end of steering arm when compared to correct steering arm assembly.

## Hendrickson Steering Arm Control Removal and Replacement Instructions

Contact Blue Bird Technical Publications for a copy of Hendrickson's steering arm removal and replacement instructions, Hendrickson Lit NO. 59310-023 dated February 2004 Revision A.
