WINDSHIELD WIPER IMPROVEMENT

UPDATE

Models Affected: 2007-10 Model Year Vision Buses with Single Wiper Motor System

S U 1 1 0 1

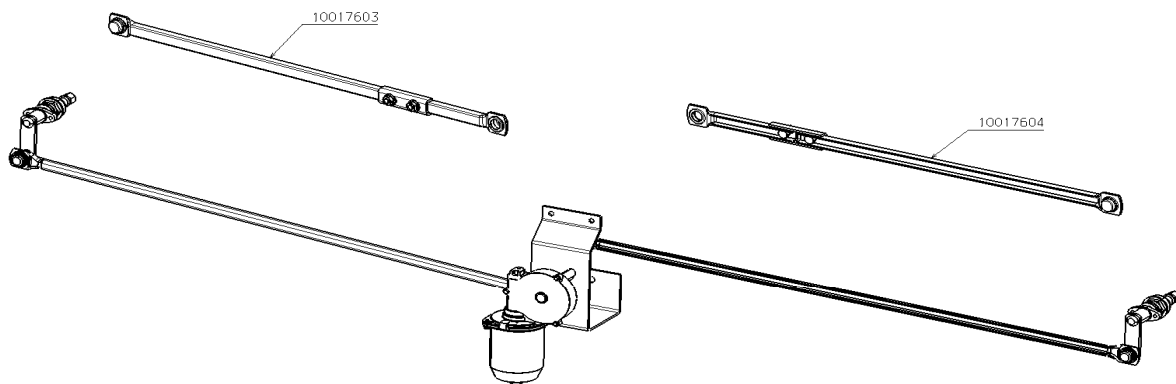
Due to variations in the location of the windshield wiper motor between the pivot points, it may be necessary to replace one of the links of the windshield wiper linkage on the side that requires adjustment with the appropriate Blue Bird service part listed below.

Wiper system improvement can be achieved without changing both links.

10017603 LINK ASSY,WIPER,24.75,16MM,BALL DRIVE,ADJ,LH (Driver's Side)

10017604 LINK ASSY,WIPER,24.75,16MM,BALL DRIVE,ADJ,RH (Curb Side)
