R00EJ

February 16, 2001

Recall R00EJ WABCO ECU Noncompliance Replacement Instructions

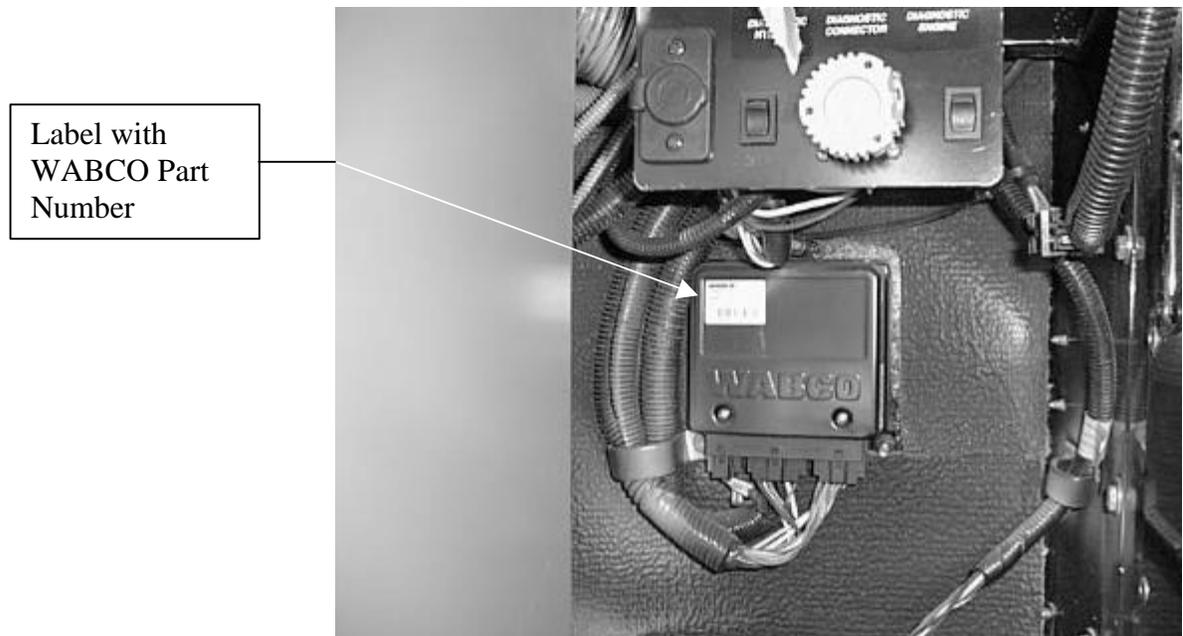
PHOTO 1

The WABCO ECU is located below the dash on the left inside front wall (see photo 1).

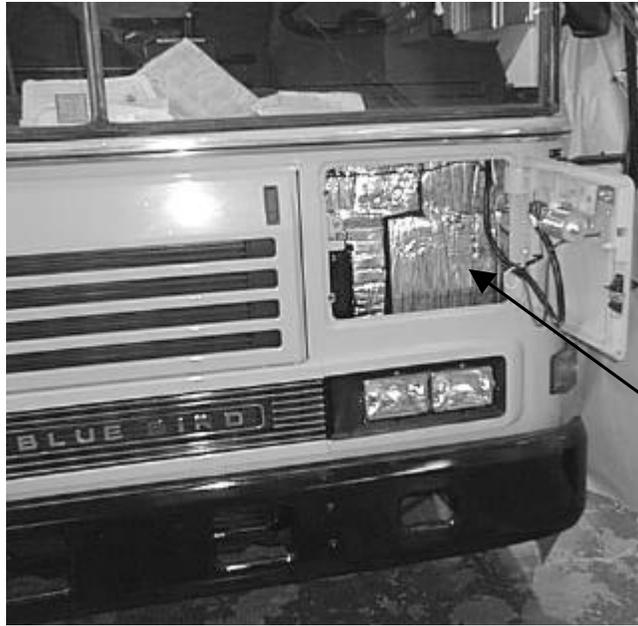
PHOTO 2

- 1 The WABCO ECU is located on the left outside front chassis outrigger behind left headlight (see photo 2).

- 2 Open left hand front windshield wiper access door. Remove the electrical access panel cover by turning latch knob counter clockwise (see Photo 2). From underneath the left front bumper, remove the electrical access panel (ECU behind panel) (see Photo 3) by removing four (4) 1/4-20 X 1" bolts, eight (8) flat washers, and four (4) 1/4-20 nuts.
