R02GC

The "Range Inhibited" indicator light for the Allison 2000 Series transmission was improperly installed and does not function on subject coaches. Blue Bird is conducting a recall to correct this defect.

RECALL R02GC 'RANGE INHIBITED' LIGHT ACTIVATION INSTRUCTIONS

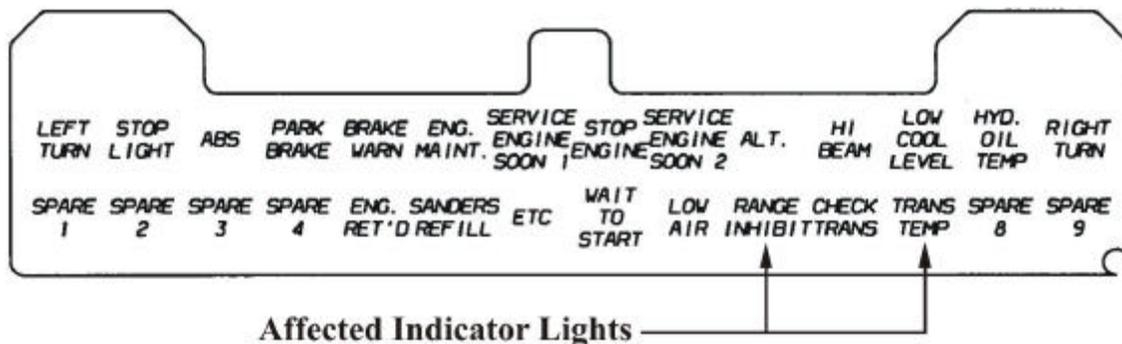
FIGURE 1

1. Park vehicle on level surface.
2. Apply parking brake.
3. You must first verify that the Allison 2000 Series transmission electronics (ECU) is sending a signal to the dash indicator lights by turning ignition on and off and seeing that the "TRANS TEMP" dash indicator light comes on for a few seconds and then goes off. The "RANGE INHIBIT" indicator light should not come on **AT THIS TIME**. The indicator lights are located on bottom of dash to right of center of dash. See Figure 1 below.

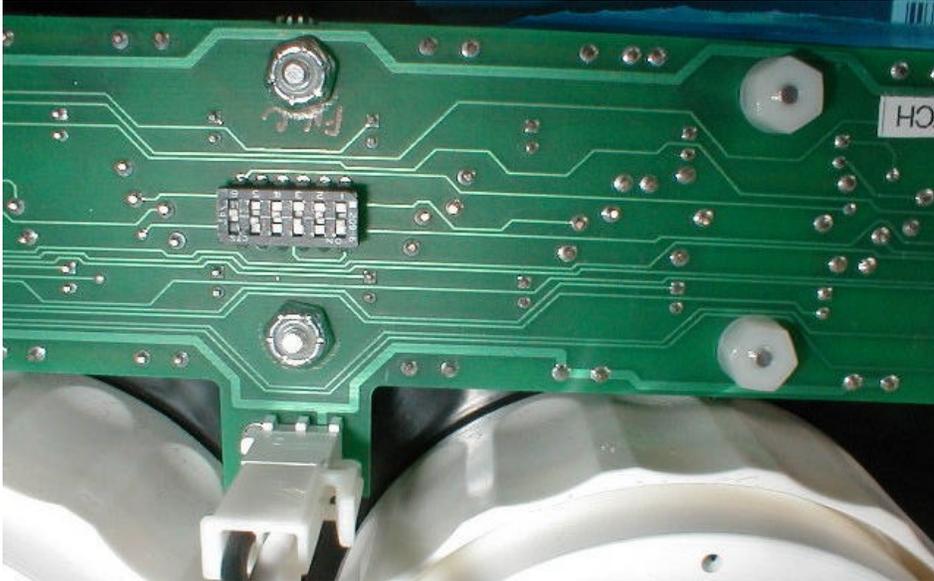
6. When sitting in the driver's seat and leaning over the dash panel, the dipswitch position 6 will be on your left and the dipswitch position 1 will be on your right. See Figure 2 below.

4. Remove the eight (8) Phillips head screws that secure the dash panel. Adjust tilt of steering column, if necessary, to gain access to screws.
5. Rotate top of dash panel towards you and lean over to view the 6-position dipswitch located on the back of the dash panel.
