R05JN

SUBJECT: RECALL R05JN INADVERTENT ENGINE SHUTDOWN

Inadvertent Engine Shutdown

MODELS AFFECTED: All Blue Bird Visions delivered through March 01, 2005

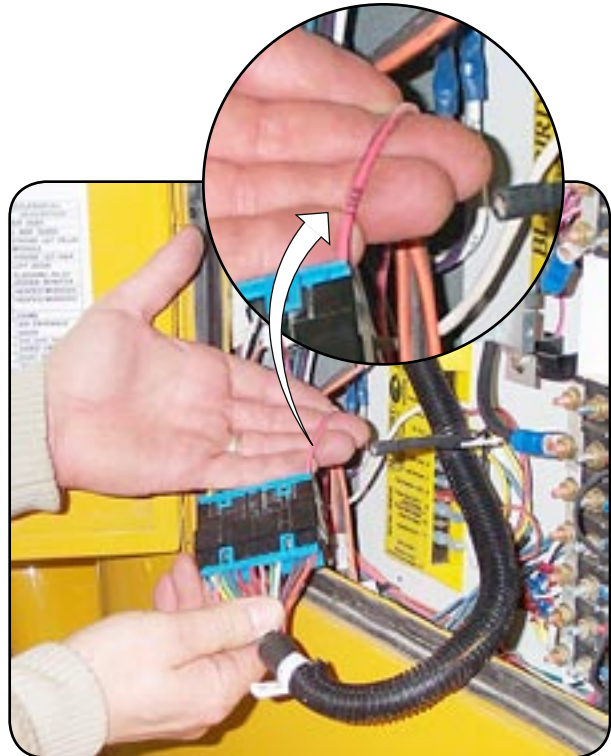
Circuit Breaker Bracket

The Body Harness Connector affected in this procedure is tucked behind the left bottom corner of the panel door post.

New breaker will be installed here, with relocated accessory wires attached.
