BLUE BIRD

R07MS

Service Bulletin 34273

Instructions for Braun Corporation "Public and Private Use" Dual Parallel Arm Lift Threshold Sensitivity Evaluation and NHTSA Compliance Applicable for NL, NCL and NVL Series Lifts

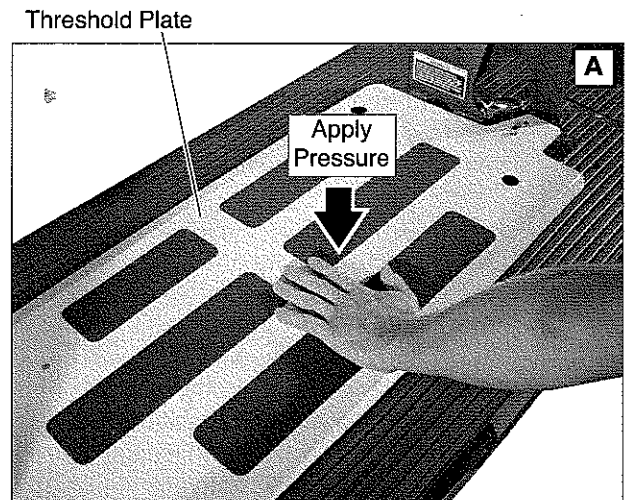
1. Turn Lift Power switch ON. Deploy the lift platform fully to the ground.
2. Apply hand pressure on the center of the threshold plate as shown in Photo A. The visual and/or audible threshold warning* should be activated when you push down.

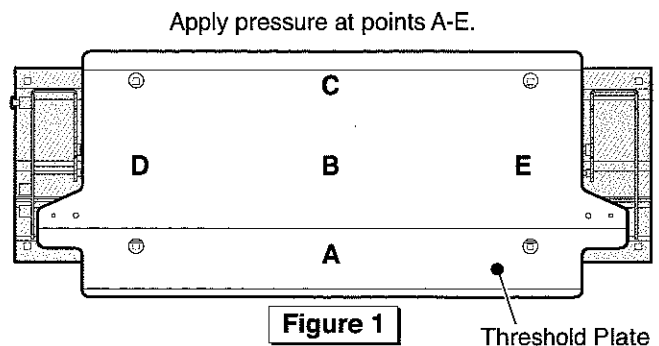
Repeat the sensitivity test procedure at positions A-E shown in Figure 1.

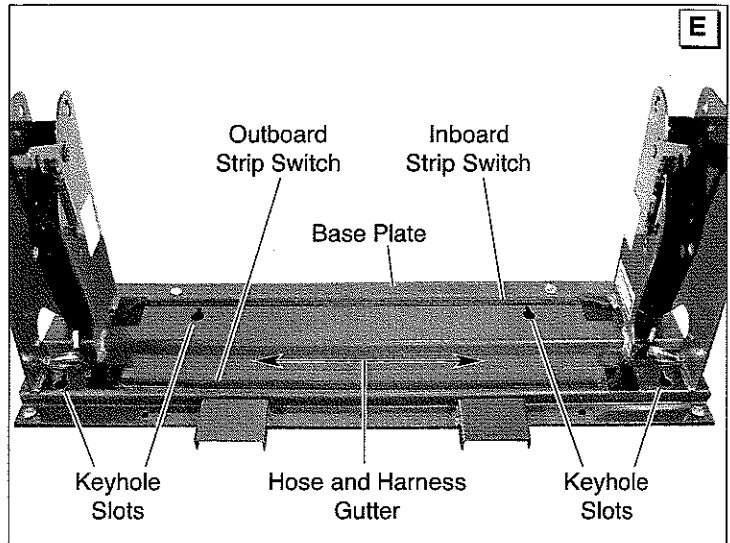
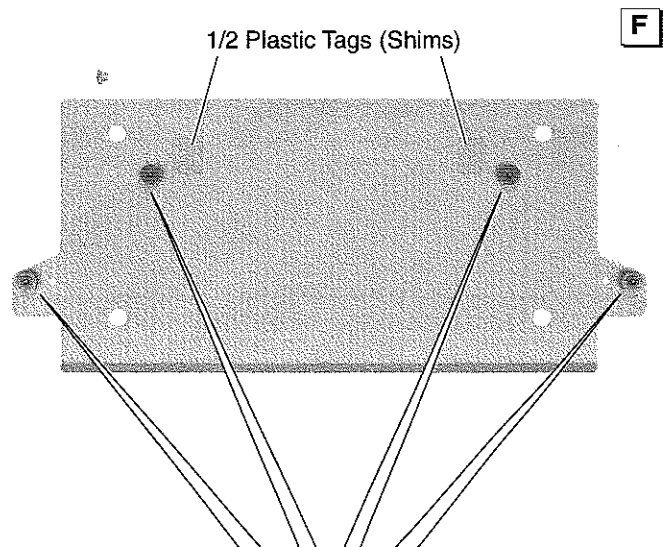
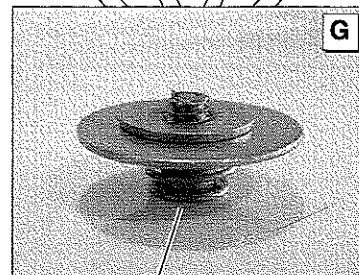
Keeper Standoffs
(Engagement Studs)

Ensure all hoses and wiring harnesses routed through the base plate gutter are positioned fully in the gutter and not located anywhere they could potentially interfere with activation of the tape switches. See Photo E.

4. Reposition the threshold plate (with shim). Align the keeper standoffs (studs) on the bottom of the threshold plate with the base plate keyhole slots. See Photos E, F and G. Insert studs and **carefully** slide the plate inward (engage slots fully).

Note: Spraying a light mist of glass cleaner (or other) to the strip switches will aid in the plate sliding easier into position. See Photos E, F and G.
