R09PL

Headlining Rivets

RECALL

MODELS AFFECTED: 2010 D3FE All American School Buses manufactured at Fort Valley, Georgia from January 19, 2009 through May 13, 2009.

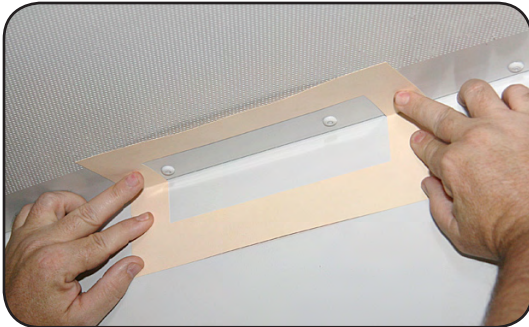
On some units, the rivet spacing may be incorrect in some segments of the rear headlining and rear upper inner panel joint, resulting in noncompliance with FMVSS 221, School Bus Body Joint Strength.

- 1** Park vehicle on level surface, apply parking brake, remove ignition key and chock wheels.
- 2** Inspect rivet spacing at rear headlining and rear upper inner panel joint. Joint must have a minimum of four rivets in an eight inch segment.
 - 2.1 Place the template over the joint and parallel to the edge of the headlining panel, allowing roof rivets to be exposed through the opening in the template as shown.
