BLUE BIRD

R10RR

Tag Light Wiring Connector Corrosion

Models Affected: 2010 All American Front Engine

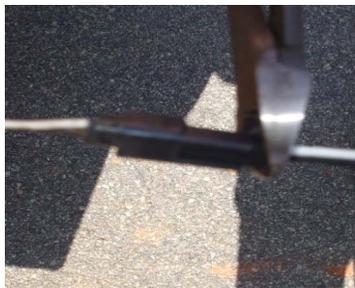
The All American tag light harness was not manufactured to design specifications. The harness length was incorrect which allowed the connector to be routed incorrectly exposing the connector to the environment and possibly allowing the connector to corrode.

1. Park the bus on a level surface, apply parking brakes, turn off engine and remove ignition key. Chock wheels.
2. Read all instructions completely before proceeding with repair.
3. Check to see if the 2-wire connector for tag light in LH rear corner of unit is exposed underneath floor of unit. If 2-wire connector is exposed, follow the instructions below to correct. If the 2-wire connector is not exposed outside of body cavity, return unit to service.
4. Disconnect Batteries – Note: when disconnecting the batteries, remove the Negative cable first.
5. Use wire cutters to cut both wires immediately adjacent to each end of the 2-wire connector.

6. Strip approximately ¼ inch of insulation from end of wires extending from body and end of wires attached to tag light.
7. Reconnect white wires using (1) 00005840 sealed butt connector and reconnect black wires using (1) 00005840 sealed butt connector. Be sure to use correct crimping tool for butt connectors. Using heat gun, heat full length of each butt connector until clear sealant in connector starts to melt and bubble up at end of butt connector, while being careful not to melt wire insulation.
8. Install split corrugated loom (01510775) over the tag light harness.
9. Reconnect batteries – Note: when connecting the batteries, connect the Positive cable first.
10. Remove wheel chocks and return unit to service.
