**R10RW**

# Incorrect Power Cable Lug Orientation

# RECALL

Models Affected: 2004 through 2009 Vision

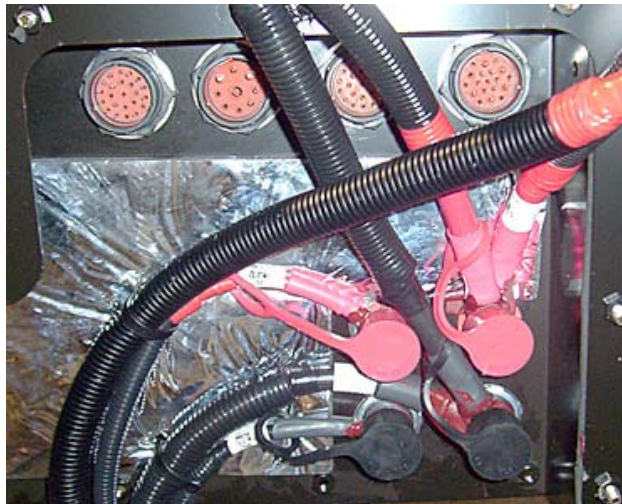
9. Next, locate and inspect the two Power Studs below the 4 Deutsch connectors.

ALL terminal lugs on each power stud should be oriented such that the barrel of the lug is further away from the mounting surface of the isolated stud. The flat side must be down.
