BLUE BIRD

R10SL

Starter Cable and Wiring Harness May Contact Engine Fan Hub

RECALL

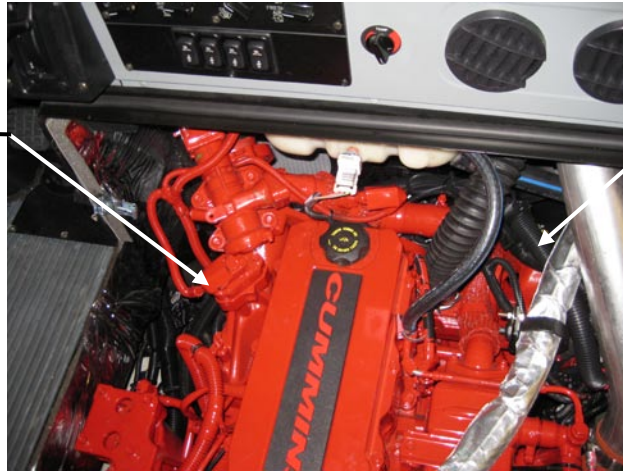
- 5 Inspect the starter cable and wiring harness from the right side of the engine, across front of engine to left side of engine for any chaffing, rubbing or damage. If starter cable and wiring harness shows any evidence of damage, contact Blue Bird Recall Administration.

Area of Left side support Bracket, See photos in step 8

Area of Right side support Bracket, See photo in Step 7
