You will find enclosed a copy of Service Bulletin S07LN regarding the routing of the alternator power cable on your Blue Bird All American model bus(es).

Alternator Cable Routing

MODELS AFFECTED: 2007 A3FE All American

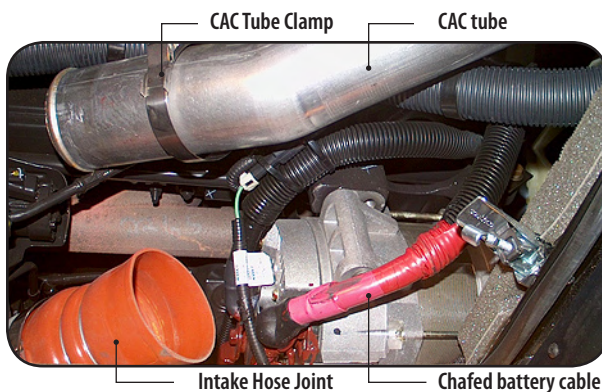
2.1 Loosen the clamp which connects the CAC tube to the orange flexible intake hose. Push the clamp forward along the CAC tube. Pull the end of the CAC tube out of the hose, and set the open end of the CAC tube on top of the engine valve cover.

WARNING Cover the open ends of both the CAC tube and the rubber hose joint to prevent contamination. Debris allowed to enter the system can cause severe engine damage.

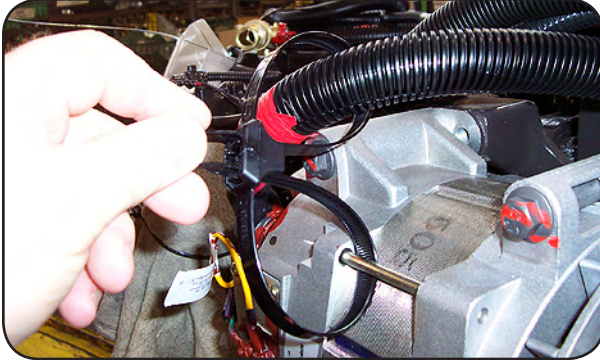
The alternator power cable is routed too close to the charge air cooler (CAC). This results in melting of the shrink wrap at the power cable connector exposing it to the elements.

The positive battery cable leading from the rear of the alternator to the Power Distribution Unit (PDU) may contact the charge air cooler tube.

Before: Cable contacting CAC tube.

4.1 With the terminal nut which secures the battery power cable to the back of the alternator loose, press the cable toward the right side of the alternator. Secure in place using the dual cable tie assembly looped around the cable and the bolt shaft of the alternator.

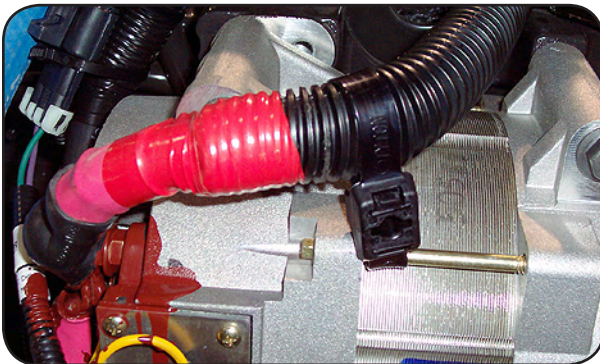
After: Cable secured to prevent contact with CAC tube.

4.2 Tighten the connector nut to 17-22 ft lb.
