R03HB

Seat Frame Anchorage

MODELS AFFECTED: All School Buses Equipped With Seat Belts or Seat Belt Ready Seats

RECALL CAMPAIGN RO3HB

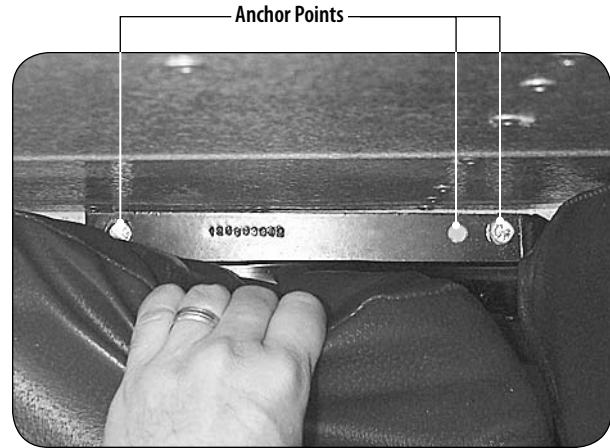
Anchor Point Inspection

Seat frame to ledge anchoring may be missing anchor bolts.

- 1** Inspect each seat frame mounting flange to wall anchoring point. Compress the seat cushion for adequate inspection. If three (3) bolts are found, **STOP**. If not, proceed to step #2.
- 2** Back drill 11/32 inch diameter hole through seat gusset ledge where required by seat frame mounting flange .
- 3** Install 5/16 - 18 x 3/4 inch bolt, BB #1032283 and nut, BB #0829390 as required. Torque bolt(s) to 18 - 20 ft. lbs.
