R04HT

3-Point Seat Belt Fasteners

MODELS AFFECTED: 2004 & 2005 A3FE with Option 2836-01, Driver's 3-Point Seat Belt

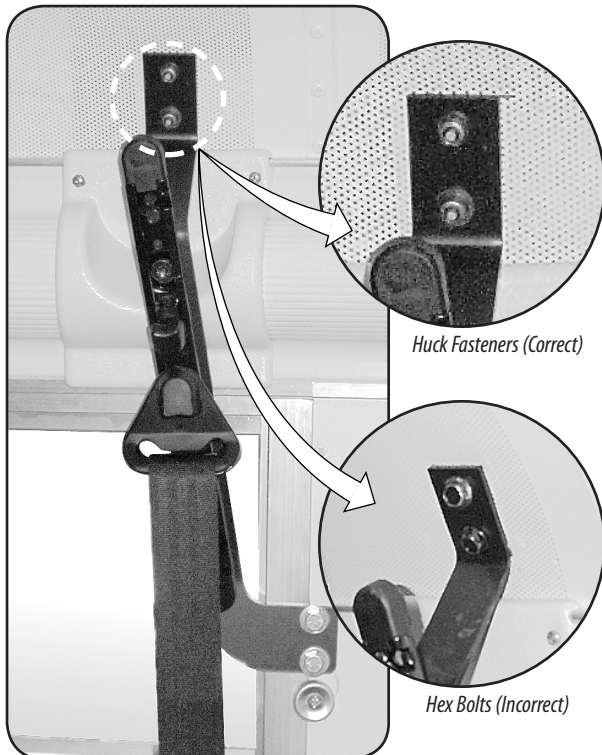
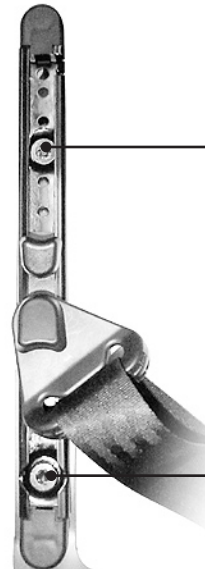
Incorrect fasteners may have been installed in upper mounting bracket of driver's shoulder belt height adjuster.

2 Remove the seat belt height adjuster bolts, using a T50 Star Bit Socket/Torx Head Bit socket.

Remove two Torx fasteners to remove shoulder belt height adjuster in order to gain necessary clearance for installing Huck fasteners.
