# Erratic Gauges

MODELS AFFECTED: All Blue Bird Visions

# BULLETIN

Intermittent electrical connections cause Blue Bird Vision dash panel to perform its start-up cycle during operation of vehicle. Gauges sweep and Warning Bank lights blink.

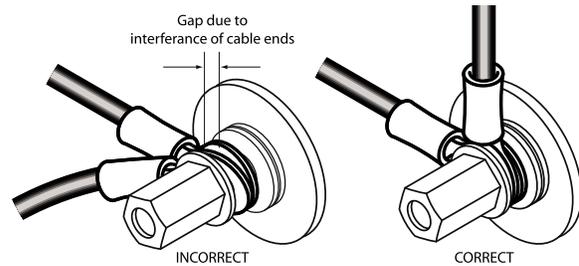
6.2 Remove the insulator cap from each stud, and inspect the connection. Ensure that all eyelets of cable ends are seated flatly between the nut and the connector stud without gaps. A nut may appear to be tight even though gaps are present due to stacking interference between connector ends, or binding of the parts.

If necessary, loosen the connection in order to relieve binding. On studs with more than one eyelet connector, orient the cable ends so that they do not bind and create gaps. Before re-tightening, fan cable ends away from each other to avoid their barrels stacking up and preventing a solid connection between eyelets.

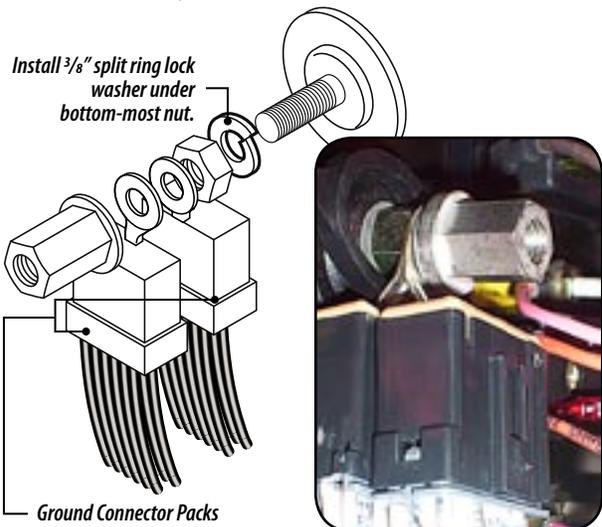
8.2 On some Visions, the Chassis Ground connector stud attaches two Ground Connector Packs. The bulk of these two Ground Packs may cause a connection gap. To provide additional stand-off space for a secure connection, install a 3/8" lockwasher under the bottom-most nut of this stud, as shown below. Torque both nuts on this stud to 11-15 ft. lbs.

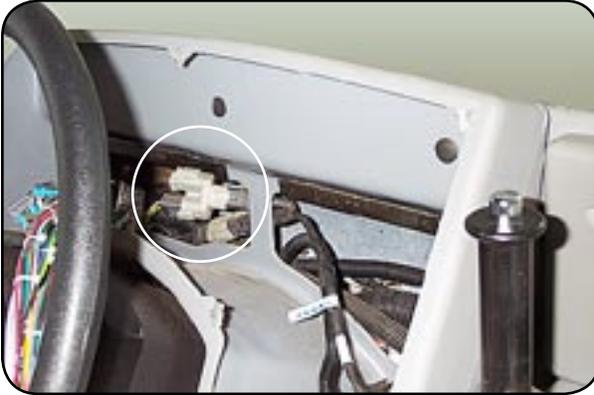
Inspect the area for any signs of abraded wires or poor connections and correct accordingly. If the J1939 cable is folded over or sharply bent against itself, unfold it if possible. Cable should be as straight as possible to eliminate stress on internal wires.

12.2 Locate the connectors shown and ensure they are securely connected.

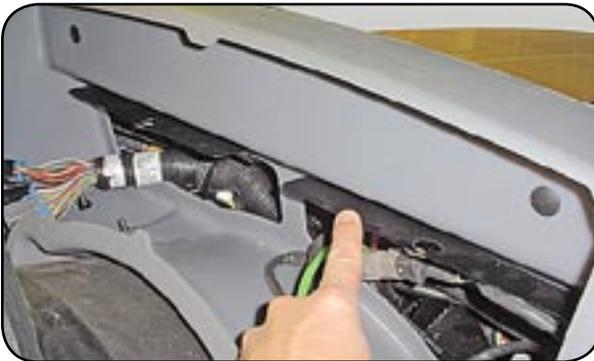
12.3 Carefully inspect the harness wires on the back side of the instrument panel for loose connectors. On some units, the rear edge of the housing retainer plate is not positioned closely against the housing, and may provide opportunity for abrasion of the nearby wires. Inspect the wires on the back of the panel for signs of abrasion or damaged insulation. Repair any damaged insulation. As a preventive measure, install a length of vinyl edge trim (BB # 1489434) along the edges of the retainer plate.
