March 03, 2010

# All American Electric Entrance Door Modification

Models Affected: 2010 All American models with feature 30978-06 DOOR CONTROL, ELECTRIC

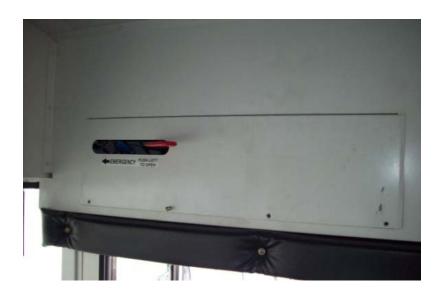
3. Remove interior access cover from entrance door header.

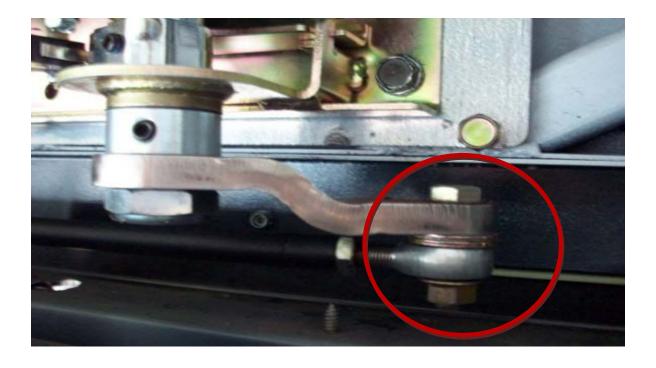
4. Loosen and remove the bolt securing the entrance door actuator lever to the linkage rod assembly.

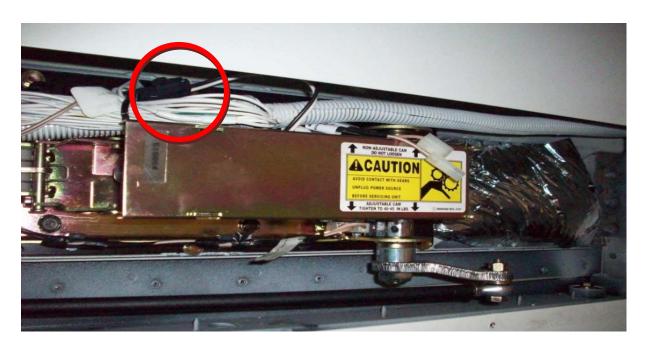
5. Disconnect entrance door motor wiring harness.

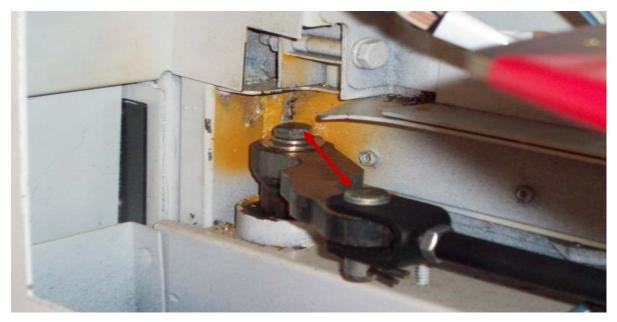
- 6. Loosen and remove bolts (6) that secure the entrance door actuator to the mounting plate assembly.
- 7. Remove and replace the entrance door actuator.
- 8. Reconnect the wiring harness to the entrance door motor.
- 9. Before reconnecting the actuator to the linkage rod assembly, power the bus and cycle the actuator to observe the motion of the actuator lever. As the door operates, the control lever should move in an arc toward the exterior of the vehicle. If the lever moves in an arc toward the interior of the vehicle, the wires (black & white) that connect to the electric motor are installed in reverse. Remove the wires and reverse their position in the connector.
- 10. Reconnect the entrance door actuator lever to the linkage rod assembly.
