BLUE BIRD

Defroster Fan Fuse Upgrade

BULLETIN

MODELS AFFECTED: 2011 MODEL YEAR BBCV "VISION" EQUIPPED WITH FEATURE 30026-06 OR 30026-07 6" AUXILIARY FAN WITH METAL GUARD.

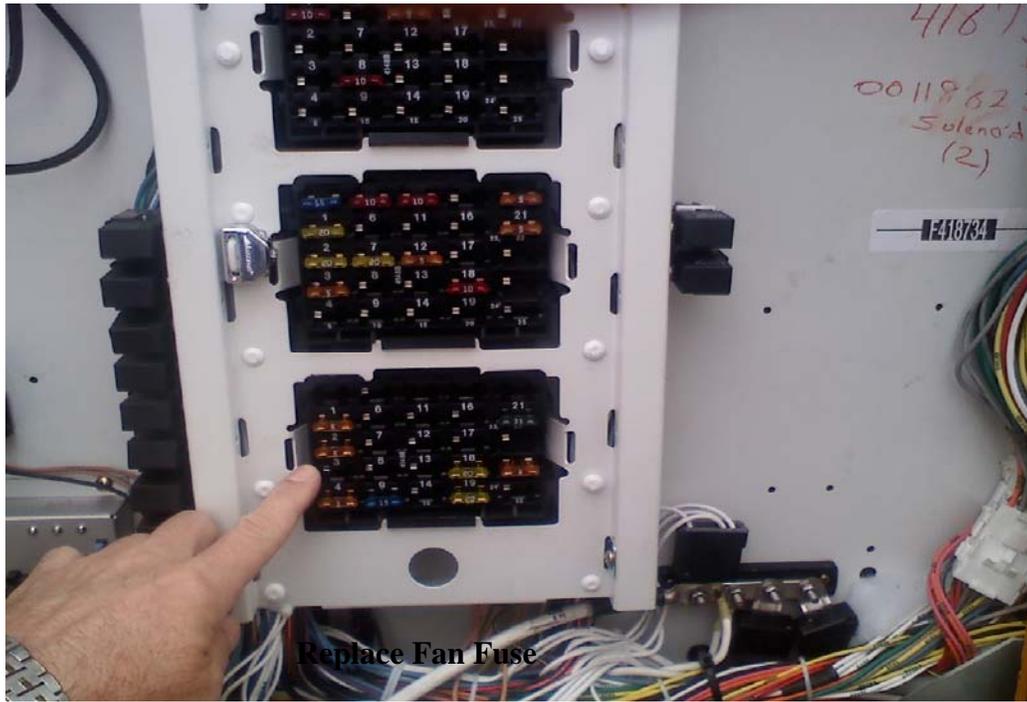
The capacity of the five amp fuses may be exceeded when heavy duty fans are started on high speed setting.

3. Replace applicable 5 amp fan fuses with 7.5 amp fuses part number 01696715 in fuse block FB3- cavity 3, 5, 7 as required (if present - see above photo)
