# Inner Fender Rock Shields

MODELS AFFECTED: 2004 Vision first generation fiberglass hoods

# BULLETIN

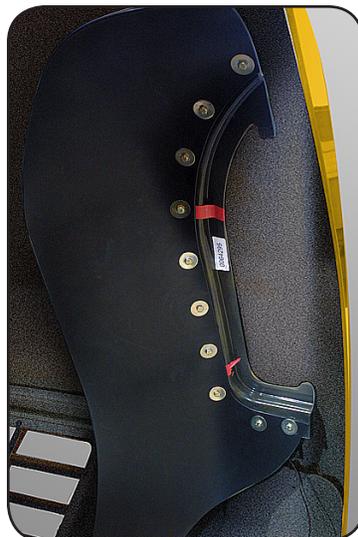
Before installation of shield

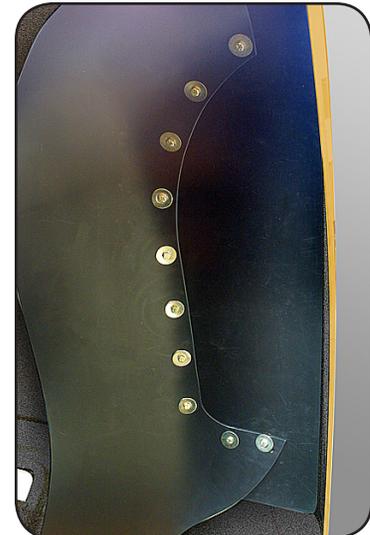
After installation of shield

**4** Reinstall the splash shield with the new rock shield sandwiched between the splash shield and the mounting flange, using the original fasteners and washers.
