You will find enclosed a copy of Service Bulletin S07MU regarding the power steering reservoir cap on your 2008 model year Blue Bird "Vision" buses.

Power Steering Reservoir Cap

MODELS AFFECTED: 2008 BBCV Vision

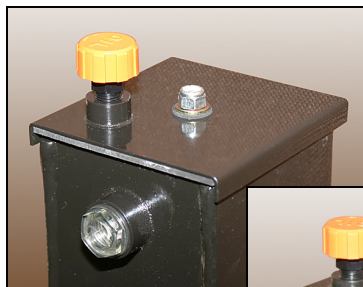
Old Design

Power Steering Reservoir Cap allows fluid leak.
