R02GR

Blue Bird Body Company has decided that a defect, which relates to motor vehicle safety exist in certain 2002-2004 model year Blue Bird TC/2000 and All American front engine school and transit buses and Commercial Series front engine transit buses manufactured from December 17, 2001 through October 28, 2002 and equipped with hydraulic brakes. Blue Bird is conducting a recall to correct this defect.

RECALL R02GR
INSTRUCTIONS FOR INSPECTING AND REROUTING
REAR HYDRAULIC BRAKE HOSE WITH MERITOR AXLE

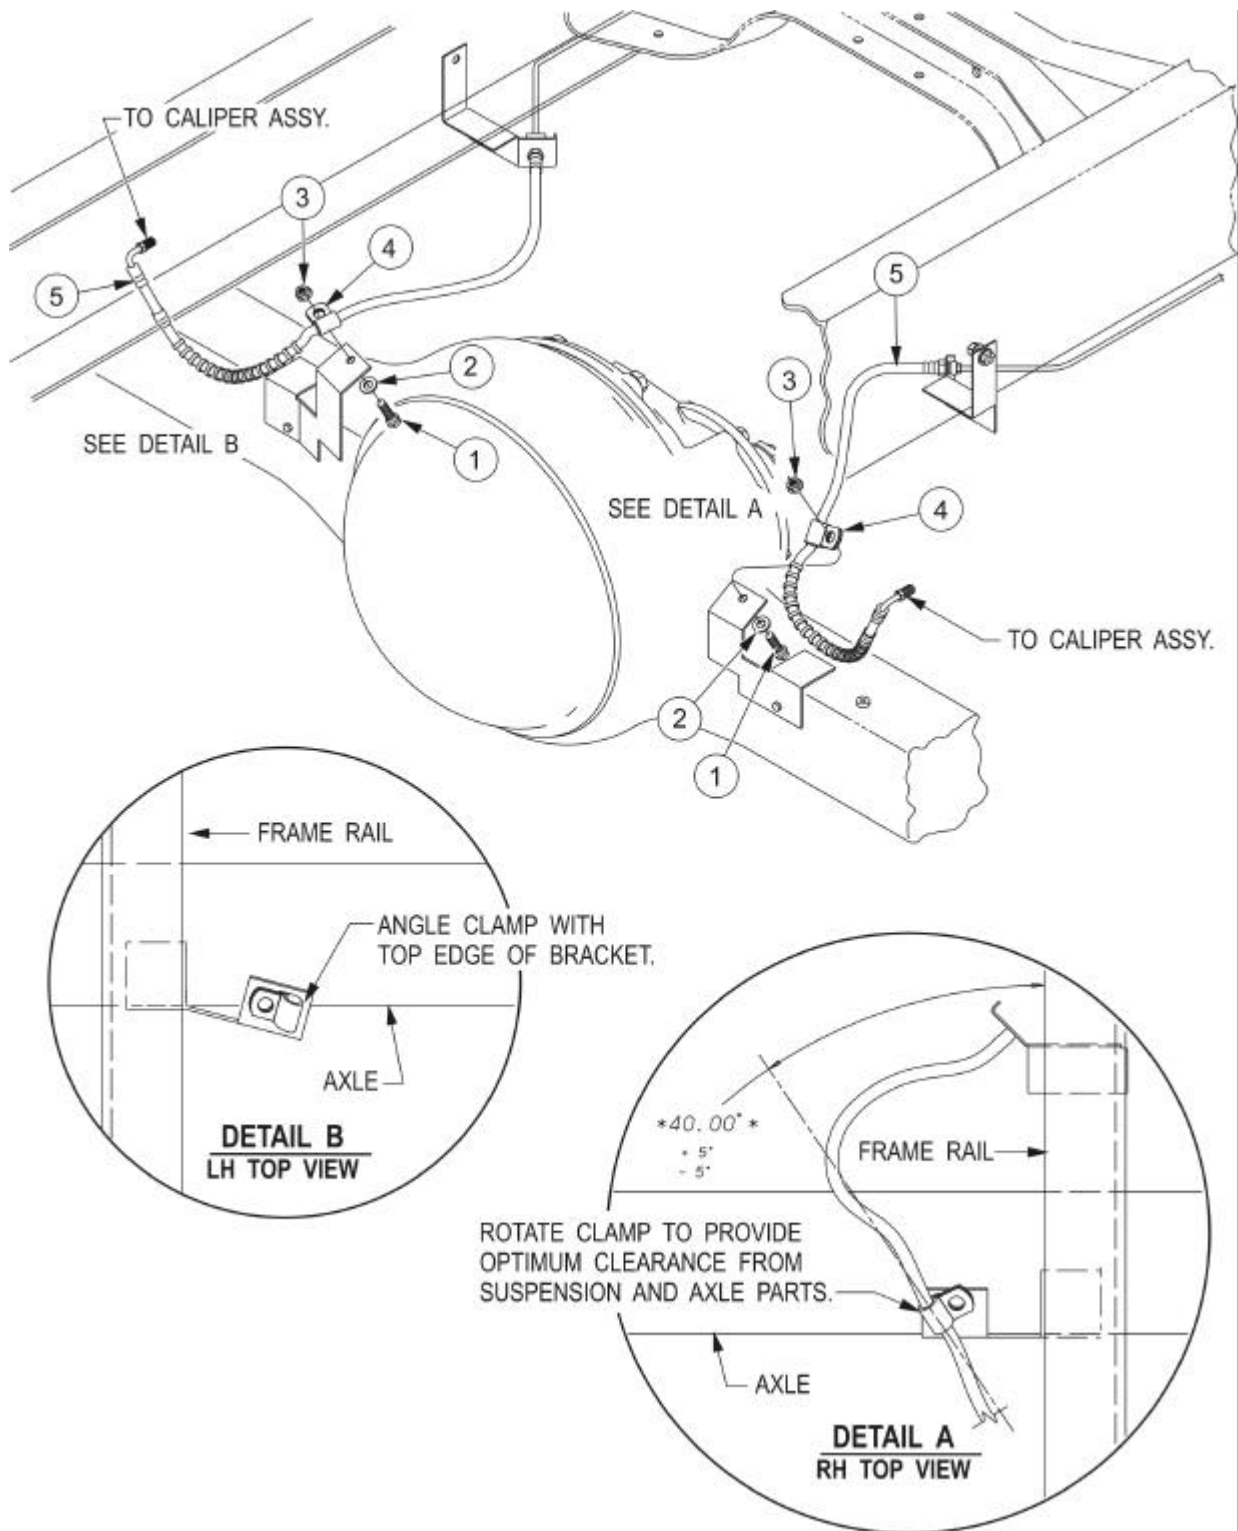
The defect involves the routing of the hydraulic brake hoses at the rear axle. The hydraulic brake hoses may not have been routed properly on subject buses. Improper routing of the hydraulic brake hoses could result in the hoses contacting the frame or frame components and abrading.

4. Review Illustration for left hand and right hand hose routing and clamp locations.
5. If the hose routing matches Illustration, STOP, no further action is required. IF NOT, reroute the hose (s) to match Illustration.

6. To reroute hose(s), remove 3/8" nut, flat washer and bolt. For right side, remove clamp from hose; reinstall clamp as shown in Detail A on Illustration. For left side, remove clamp from hose; reinstall clamp as shown in Detail B on Illustration. Reinstall 3/8" bolt, flat washer, and nut. Torque nut to 25-30 Ft. Lbs.
