R03HC

Davenport Seat Belt Anchorage

MODELS AFFECTED: 2004 Blue Bird All American Rear Engines (A3RE) with Seat Belts

RECALL CAMPAIGN RO3HC

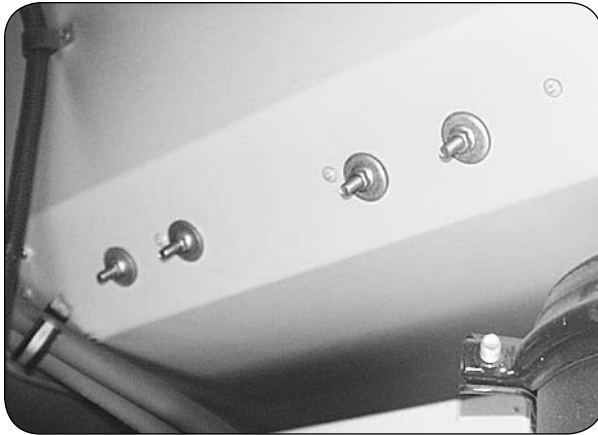
Figure 1

- 1** Park the bus on a level surface and apply the parking brake. Remove the key and chock the wheels. Disconnect the battery cables.
- 2** Open the engine compartment, allow the engine ample time to cool to ambient temperature.
- 3** Inspect the seat belt anchorage bolts protruding from the rear davenport wall. If the fasteners appear as shown in Figures 1 or 2 **STOP**. These installations are acceptable.

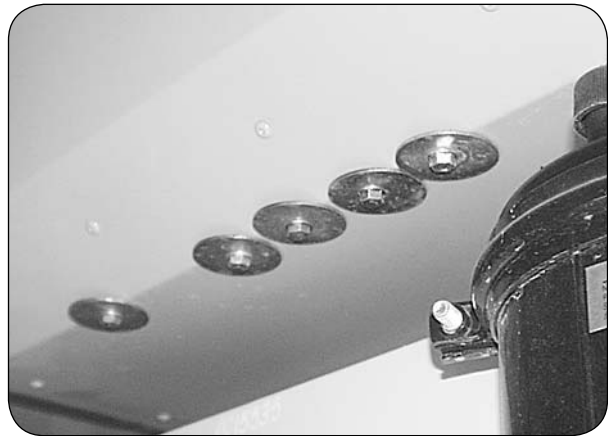
Figure 3

The spacing and location of the davenport seat belt anchoring bolts are not within specified parameters. In addition, incorrect bolts, washers and nuts may have been installed.

If the seat belt anchorage bolts are installed as shown in Figure 3, proceed to Step 4.

Remove original davenport seat belt anchoring bolts. Drill new holes at the correct location and install correct bolts, washers and nuts.

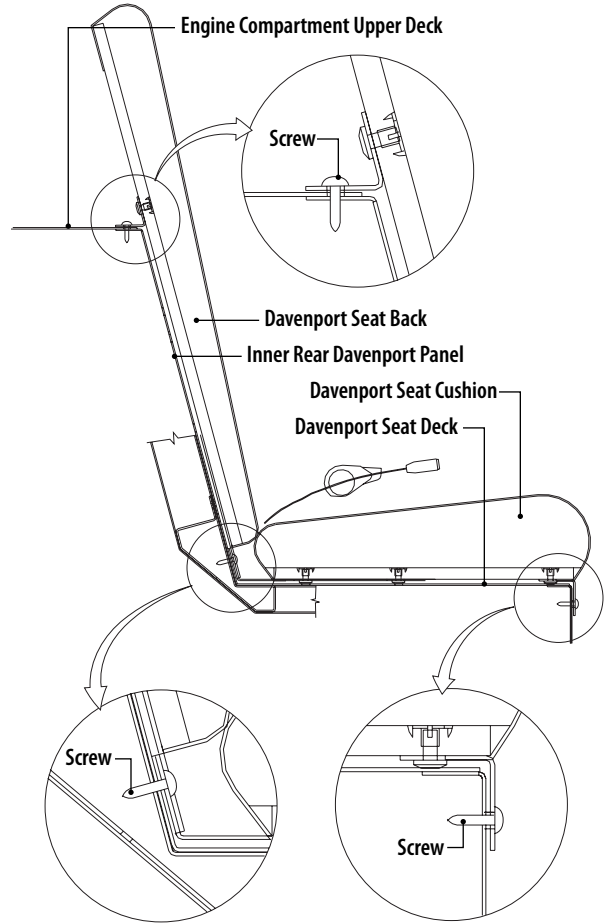
Steps Four Through Six

4 Remove screws that secure both davenport seat backs to the rear engine compartment upper deck. Lift and remove the seat backs.

5 Compress the rear of the davenport seat cushion and remove the screws that secure the seat cushions to the inner rear davenport panel.

6 Remove screws that secure the front edge of the davenport seat cushions. Lift and remove the seat cushions.

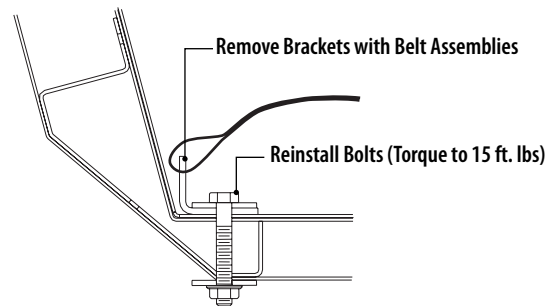
Steps Seven & Eight

7 Remove and retain all seat belt assemblies with mounting brackets from the davenport seat deck.

8 Reinstall the old bolts, washers and nuts into their original locations and torque to 15 ft. lbs.

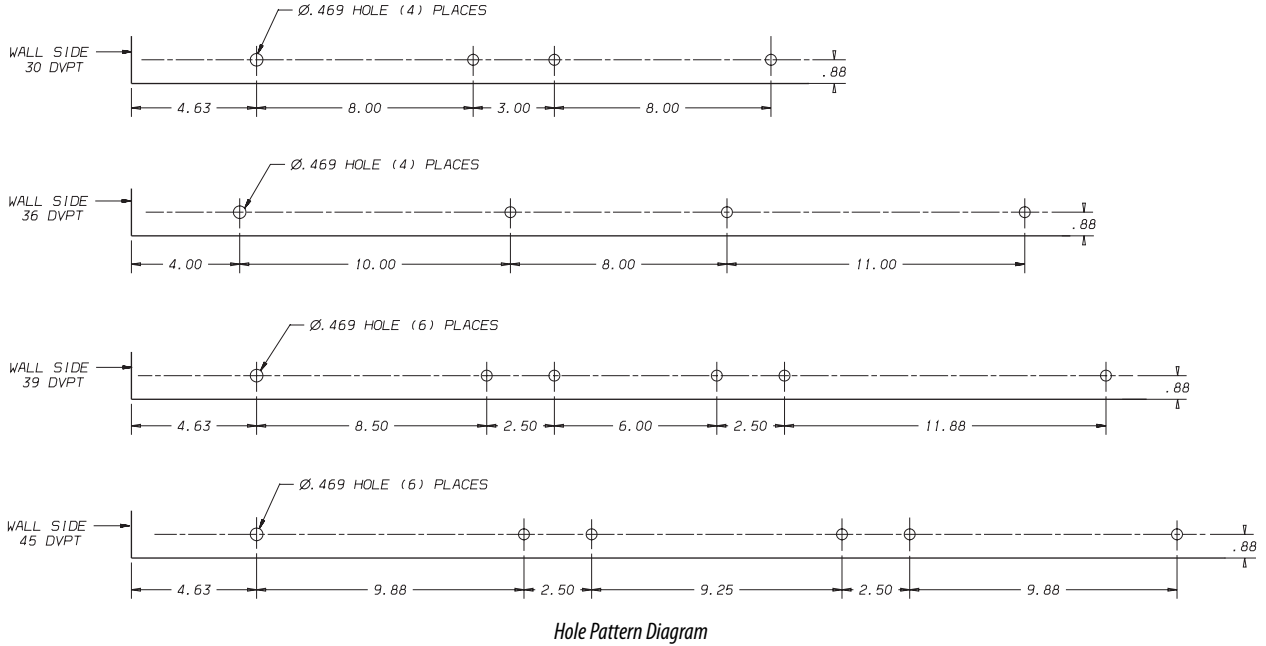
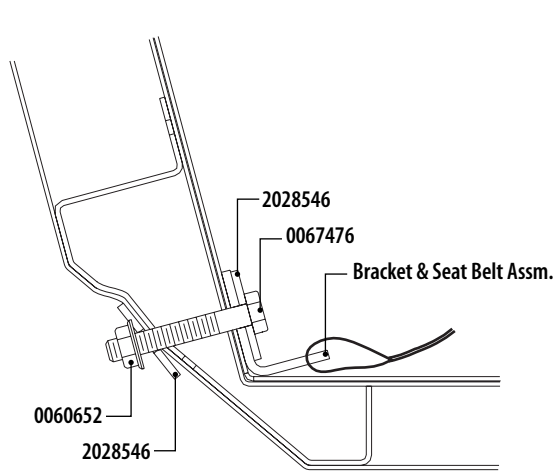
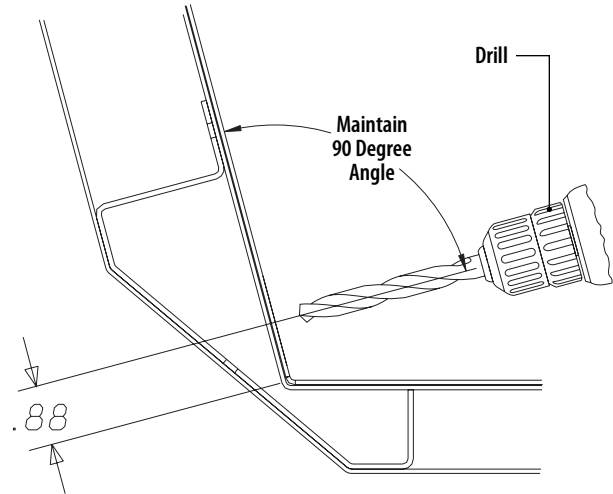
6 Using the hole pattern diagram that coincides with your seat size, drill 15/32 inch (.468) diameter holes through the rear davenport panel 7/8 inch (.88) above davenport seat deck. Maintain the drill at a 90 degree angle to the rear davenport seat panel. See "Hole Pattern Diagram" on page 3.

8 Install bracket with seat belt in new position as shown in "Seat Belt Bracket Installation" on page 3. Install new 7/16 - 20 x 2.25 inch bolt (BB #0067476), two flat washers (BB #2028546) and flanged nut (BB #0060652). Bolts must be torqued to 30-33 ft. lbs.

Note: When torquing bolts during installation, panel compression may occur along the top edge of the nut and washer. At the same time, a gap may be noticed at the lower edge of the nut and/or washer. This condition is acceptable.
