R03HL

RECALL CAMPAIGN RO3HL

Park Brake Valve Exhaust Port Blockage

MODELS AFFECTED: 2004 Blue Bird Visions (BBCV) with Air Brakes

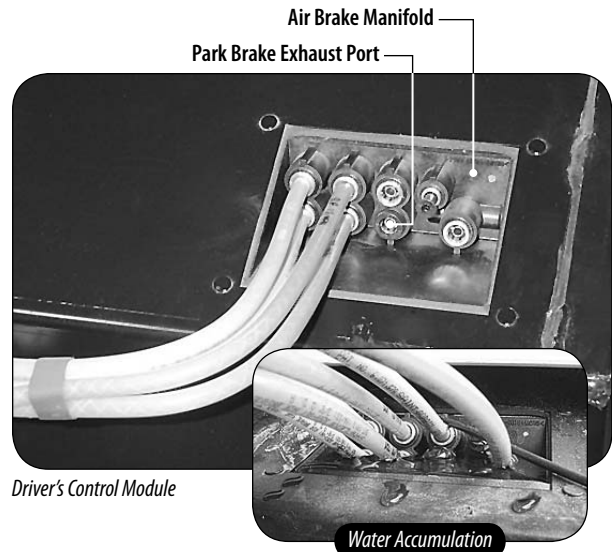
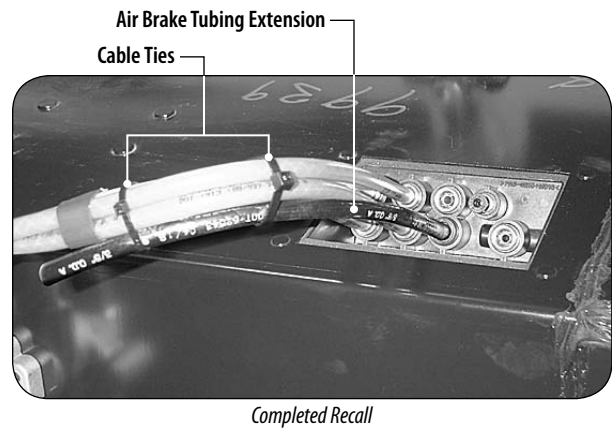
The air brake valve manifold on the Bendix designed Driver's Control Module may retain rain water runoff causing overflow into the parking brake valve exhaust port. In freezing temperatures the frozen water could block the exhaust port causing the parking brake valve to not operate as designed.

- 2 Raise the engine hood and locate the air brake manifold on the driver's control module.

- 3 Locate the park brake exhaust port. Remove any accumulated water before proceeding.

A 3/8 inch O.D. air brake tubing extension is added to the exhaust valve port preventing water entry into the port.

- 4 Insert the 3/8 inch air brake tubing extension into the park brake exhaust port until tube bottoms against the inside of the fitting.

- 5 Attach the tube to the existing air brake tubes with two cable ties and cut off the end of the ties.
