R04HV

INSTRUCTIONS FOR RECALL R04HV

REAR ROOF SHEET TO REAR ROOF CAP JOINT RIVET INSPECTION AND REPAIR PROCEDURES

Rear Roof Cap Rivets

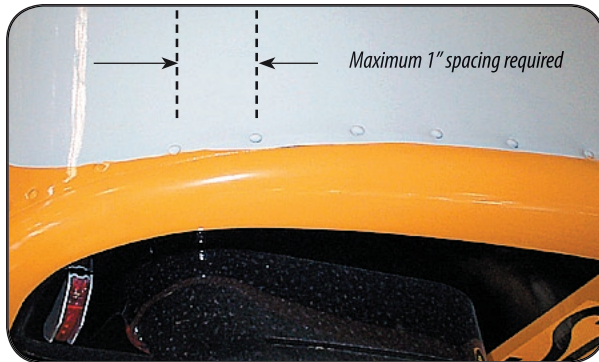
1 Inspect the rivet spacing along the joint of the rear roof sheet and the rear roof cap. Rivets must be added wherever center-to-center spacing is greater than 1 inch. A spacing template is provided to aid inspection and marking of locations for new rivets.

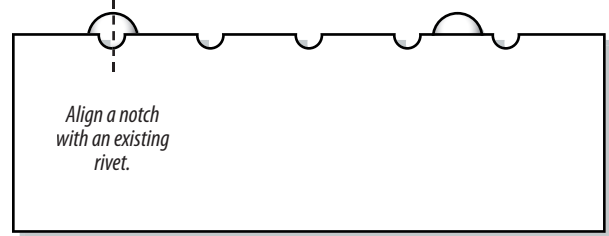
1.1 Align a notch of the template with a rivet on the bus. The notches of the template are spaced at the required 1-inch increments.

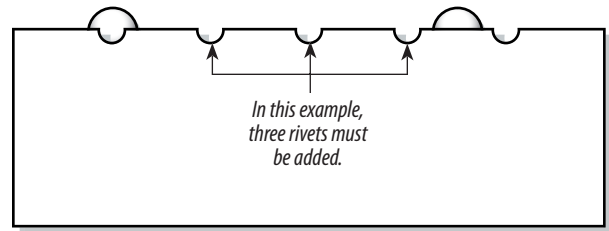
1.2 If the next notch does not reach the next rivet on the bus, at least one rivet must be added. Count the number of notches which do not have corresponding rivets on the bus. That is the number of rivets which must be added between the two existing rivets.

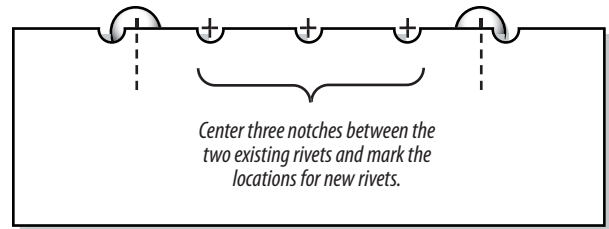
1.3 Visually center the number of required notches between the two existing rivets, and mark the locations.

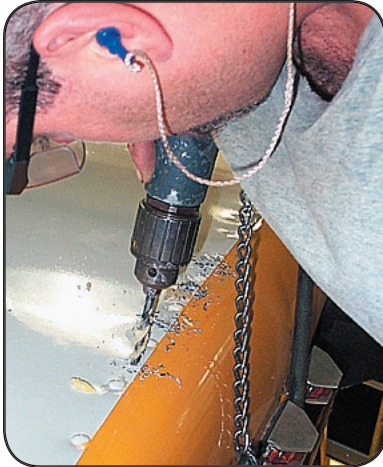
2 At each mark, using a short $\frac{1}{64}$ " drill bit, drill a hole through the roof cap, roof sheet, and rear bow flange. Be sure to drill hole on a common centerline with existing rivets.

2. Using the template, mark each location that requires additional rivets.
3. For each additional rivet needed, using a short drill bit, drill a 17/64" diameter hole through roof cap, roof sheet and rear bow flange. Be sure to drill hole in line with existing rivets

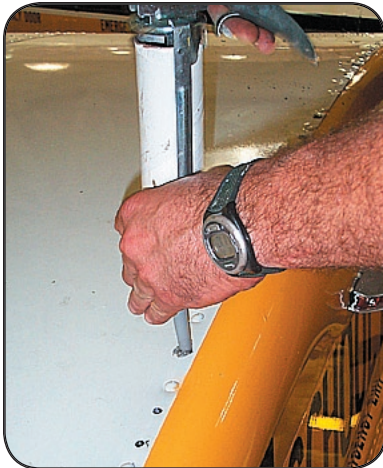
3 Place a small amount of Vinyl Gray 5522 Sealant (Blue Bird # 0898627) in each drilled hole.

4. Place a small amount of Vinyl Gray 5522 Sealant Blue Bird # 0898627 in each drilled hole.
5. Blue Bird will furnish 1/4 blind rivets BB # 1854397 already painted School Bus Chrome (yellow) or white for your bus. Install the correct color 1/4 blind rivets into each hole.

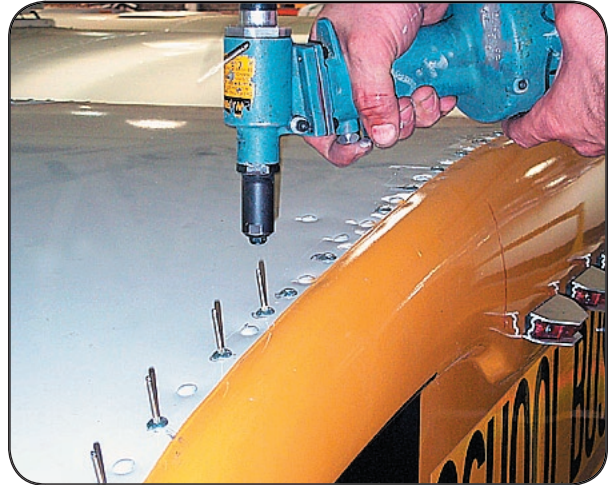
4 The supplied $\frac{1}{4}$ " blind rivets (Blue Bird # 1854397) are pre-painted white or school bus chrome yellow. Install a rivet of the appropriate color into each hole.

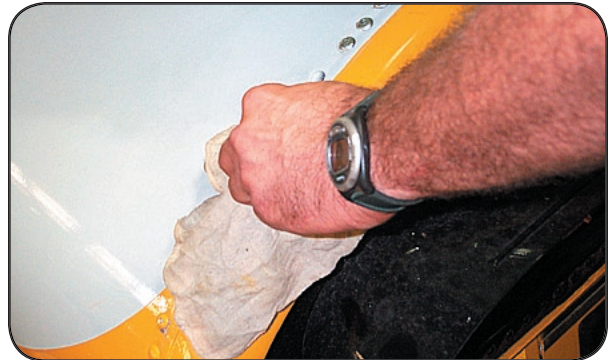
5 Clean up any sealant that may have squeezed out or smeared during rivet installation.

6. Clean any sealant that may have squeezed out during rivet installation.
7. Touch up the center of the blind rivet where the stem has been removed during installation with the correct color touch up paint.

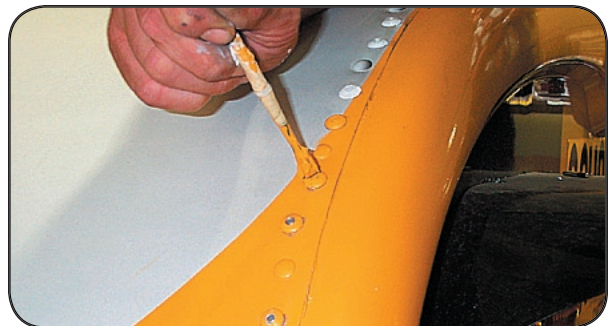
6 With the correct color paint, touch up the center of each blind rivet where the stem was removed during installation.
