**SUBJECT: SERVICE BULLETIN S07LV CHARGE AIR COOLER HOSE
CLAMPS**

**AFFECTED: CERTAIN 2008 MODEL YEAR ALL AMERICAN REAR ENGINE
BUSES EQUIPPED WITH CUMMINS ISC-07**

CAC Hose Clamps *BULLETIN*

MODELS AFFECTED: A3RE All Americans w/Cummins ISC-07 Engines

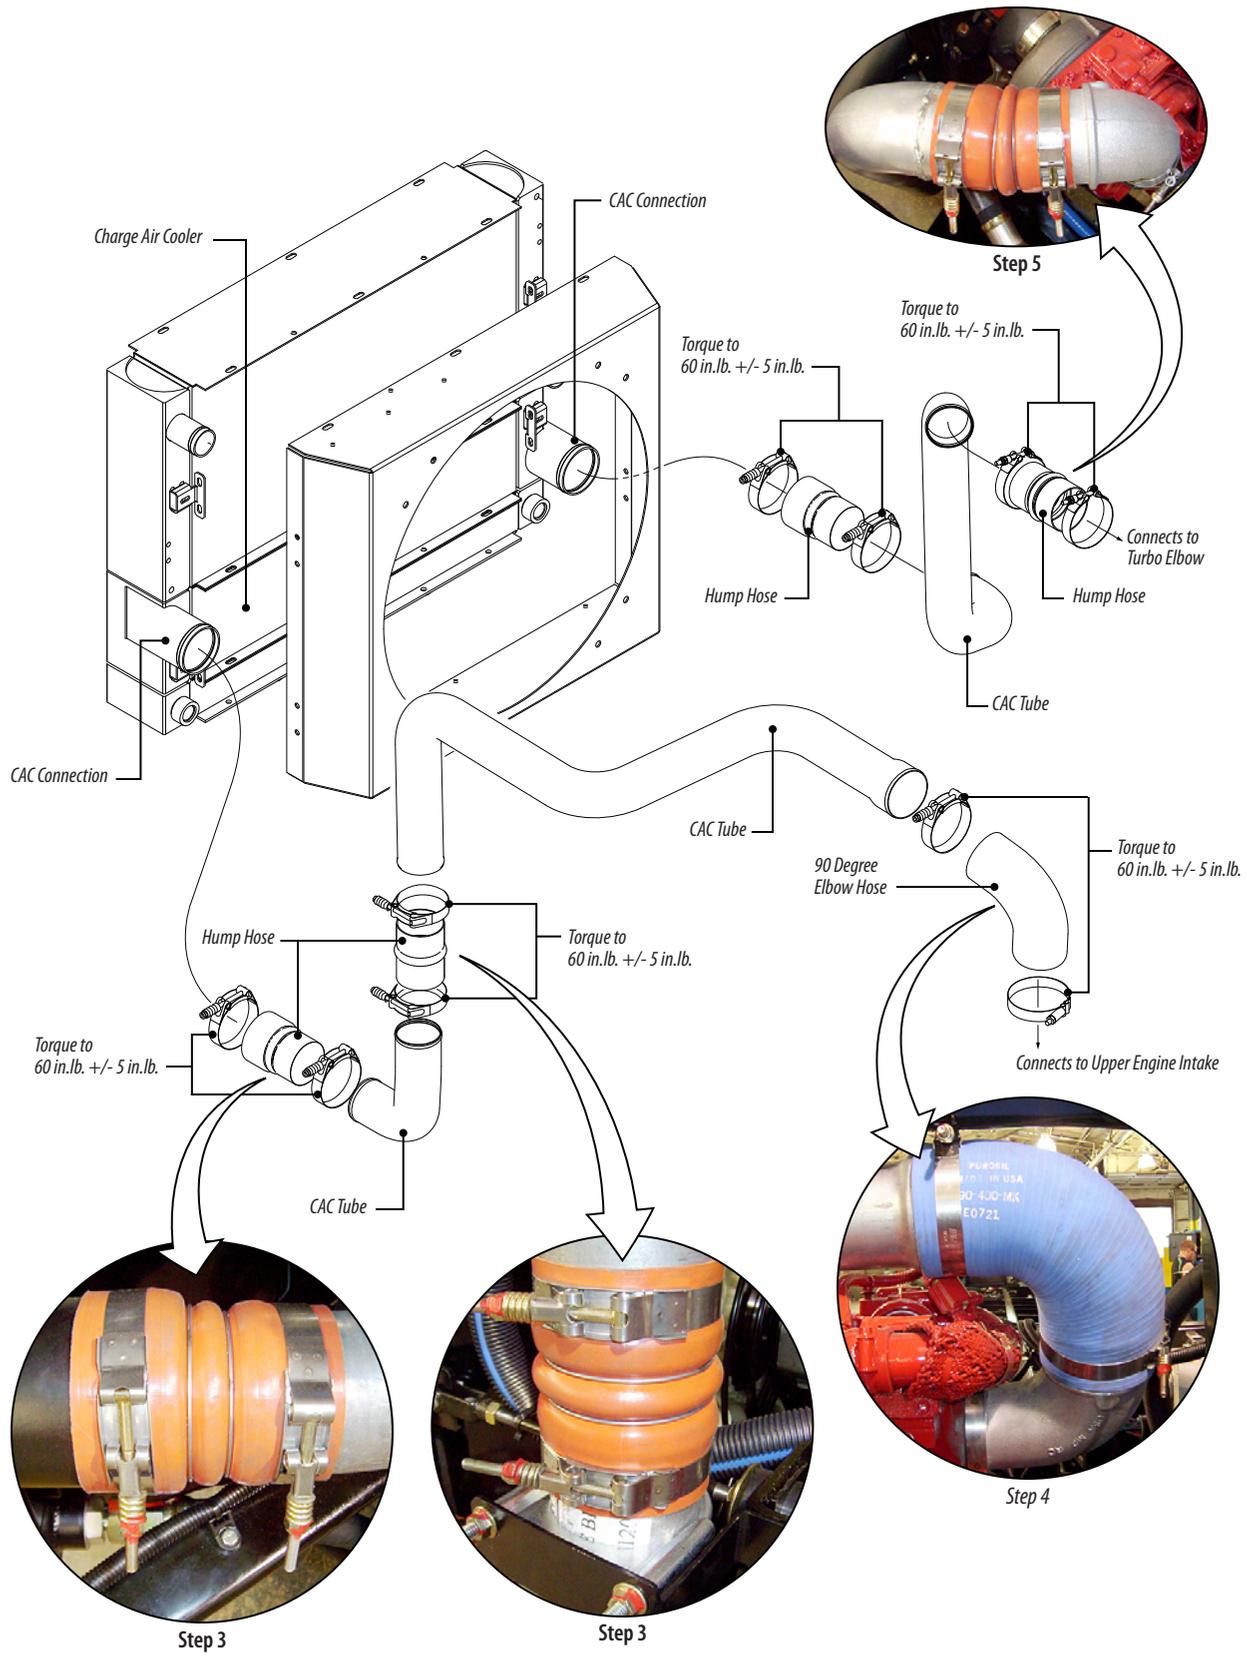
3 Inspect the Charge Air Cooler Air Intake System to ensure that all Hump Hoses are installed past the knurl on the CAC Connection and on the CAC Tubes. In order to achieve a constant torque the clamp must be installed as shown.

4 Inspect the 90 Degree Elbow Hose to ensure that it is installed past the knurl on the CAC Tube and on the engine air intake elbow. In order to achieve a constant torque the clamp must be installed as shown.

5 Inspect the Hump Hose at the turbo outlet elbow to ensure that it is installed past the knurl on the CAC Tube and on the turbo outlet elbow. In order to achieve a constant torque the clamp must be installed as shown.

6 If any connection is installed crooked or the clamp is not installed fully over the CAC tube and beyond the knurl, then loosen the clamp, reinstall the hose and re-torque the clamp to 60 in. lb. +/- 5 in. lb.

7 Re-torque all ten (10) clamps to 60 in. lb. +/- 5 in. lb. If the clamp has been torqued to a higher torque than 60 in. lb. +/- 5 in. lb, then loosen the clamp and re-torque to 60 in. lb. +/- 5 in. lb. If the clamp has been damaged because of over torque, then replace with a new constant torque clamp and tighten to 60 in. lb. +/- 5 in. lb.
