**R10RW**

# Incorrect Power Cable Lug Orientation

# RECALL

Models Affected: 2004 through 2009 Vision

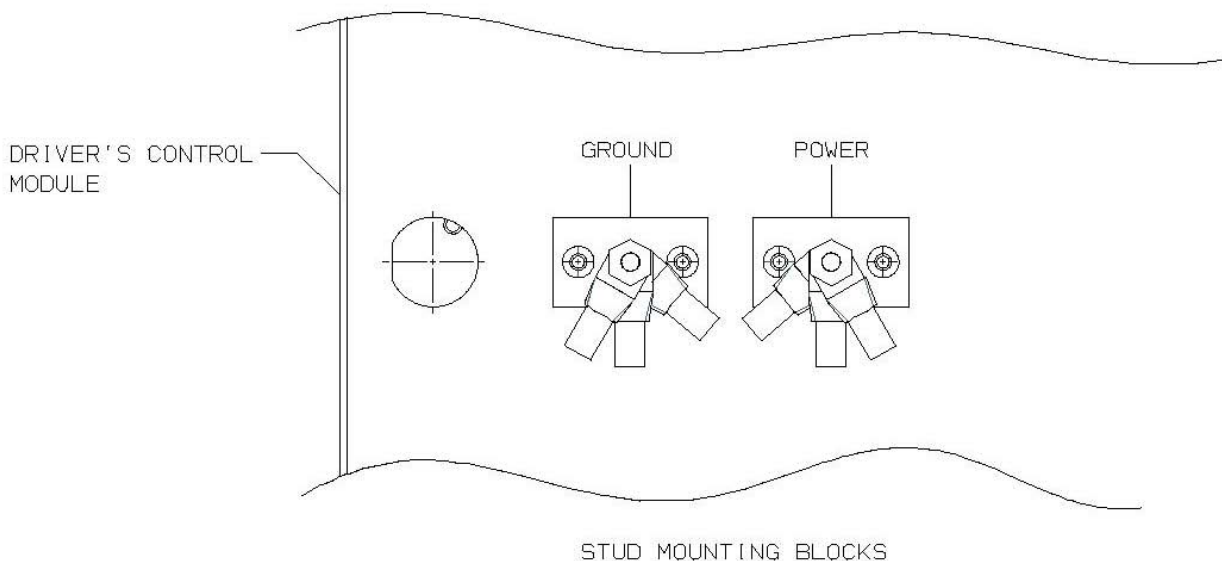
1. Park the vehicle on a level surface, apply parking brake, turn engine off, remove ignition key and chock wheels.
2. Disconnect batteries. *Always remove negative cables first.*
3. Open engine hood and locate the Chassis Power Stud(s) on the driver's side of the **Driver's Control Module (DCM)**. Depending on the type of engine installed and options on the vehicle (air conditioning and/or lift), there could be one or two power studs next to the Ground Stud. See the following diagrams.

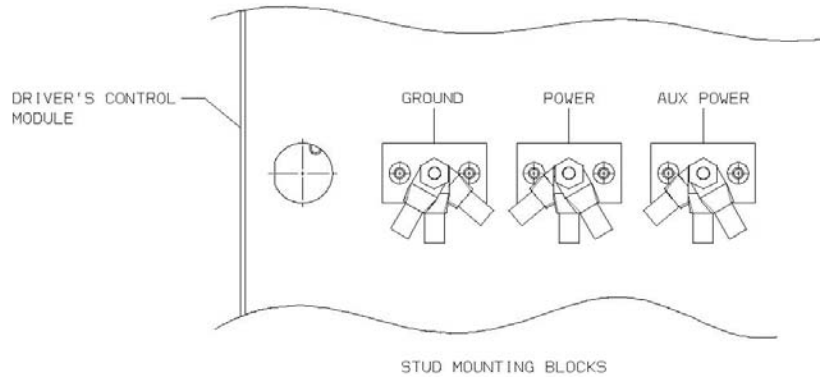
4. Inspect the electrical cable connections at the Power Stud and Aux Power Stud, if installed. See the diagram below to determine if the cables were installed correctly. ALL terminal lugs on each power stud should be oriented such that the barrel of the lug is further away from the mounting surface of the isolated stud. The flat side of terminal end (lug) must be down.

5. If the cables were installed incorrectly, remove the nut securing the cables. Then remove the cables and reinstall correctly per the diagram above. Make sure the terminal lugs are fanned out on the stud as opposed to directly on top of each other. Vice-grip pliers are recommended when turning incorrectly installed cable terminal lug to the correct orientation of flat side down.
