# Erratic Gauges

MODELS AFFECTED: All Blue Bird Visions

# BULLETIN

Intermittent electrical connections cause Blue Bird Vision dash panel to perform its start-up cycle during operation of vehicle. Gauges sweep and Warning Bank lights blink.

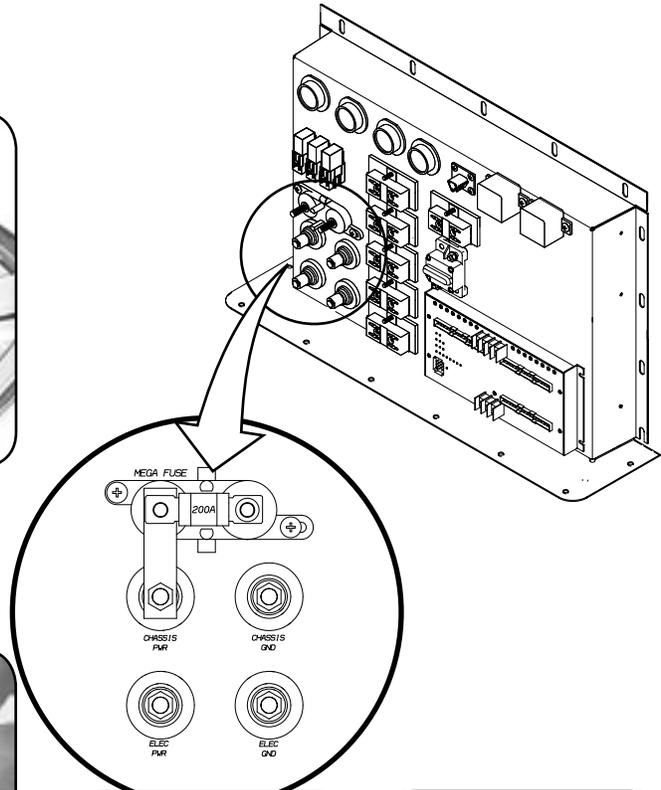
6 studs viewed from passenger side of PDU panel

4 studs viewed from engine side of PDU panel

**5** Six large connection studs located at the left bottom of the PDU must be checked. Four of these are pass-through connectors and must be checked on both sides of the panel. This will require unbolting the PDU panel for access.

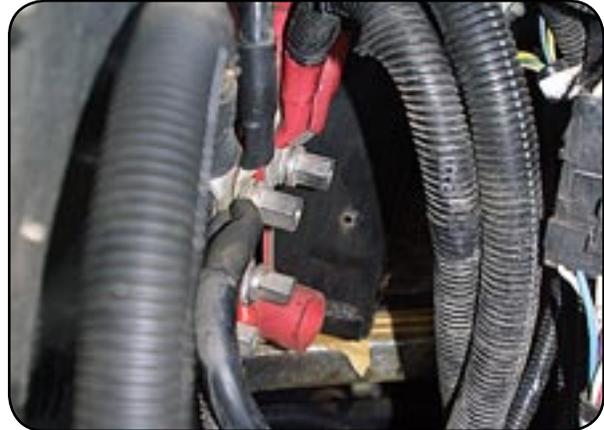
*4 studs on engine compartment side of panel (rubber insulator caps removed)*

6.1 Locate the four pass-through connector studs on the engine compartment side of the panel.

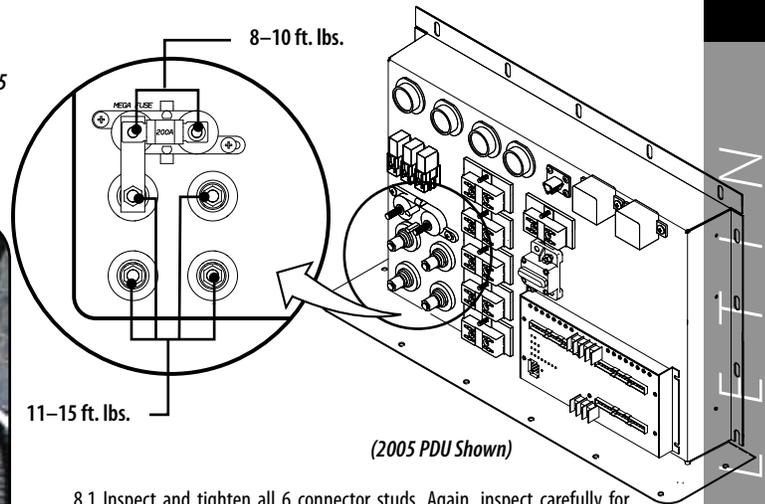
**8** Similarly inspect and tighten the connector studs on the bus interior side of the PDU Panel. Before proceeding, note the difference which exists between 2004-05 model Visions and 2006 model Visions, described below:

8.1 Inspect and tighten all 6 connector studs. Again, inspect carefully for any connection gaps or loosening between cable eyelets due to binding or arrangement of cable ends. Torque connector stud nuts to the values shown above.

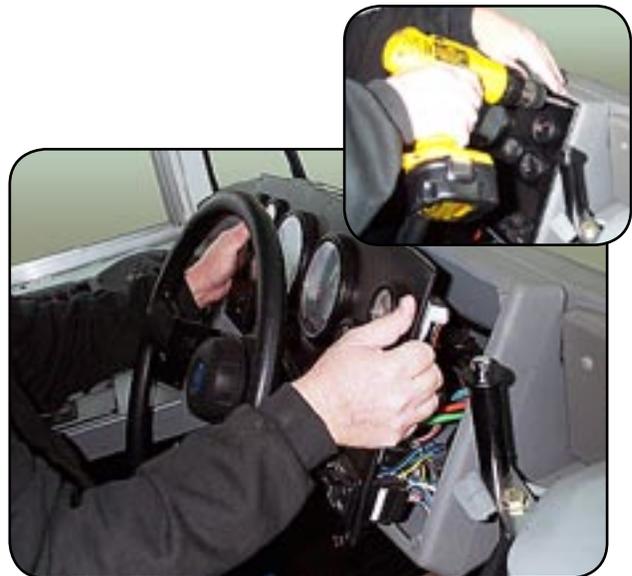
Inspect the area for any signs of abraded wires or poor connections and correct accordingly. If the J1939 cable is folded over or sharply bent against itself, unfold it if possible. Cable should be as straight as possible to eliminate stress on internal wires.

12.2 Locate the connectors shown and ensure they are securely connected.
