R02GP

**Recall R02GP
Throttle Position Sensor Date Code
Inspection Sheet**

Electronic Foot Pedal Caterpillar Throttle Sensor Replacement Instructions

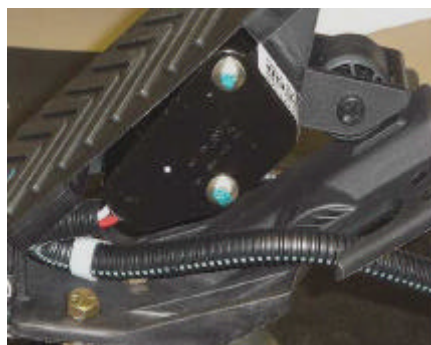
You must have the Felsted electronic accelerator pedal inspected for defective throttle position sensors. Defective throttle position sensors will have date codes from FE111 through FJ161. The throttle position sensor date codes on each of your buses must be recorded on the attached sheet and returned to Blue Bird in the pink postage paid reply envelope. Date code is located on white decal on forward side of throttle position sensor.
