# Air Intake Tube BULLETIN

MODELS AFFECTED: A3FE All Americans w/Cummins ISB02 Engines

S07LR

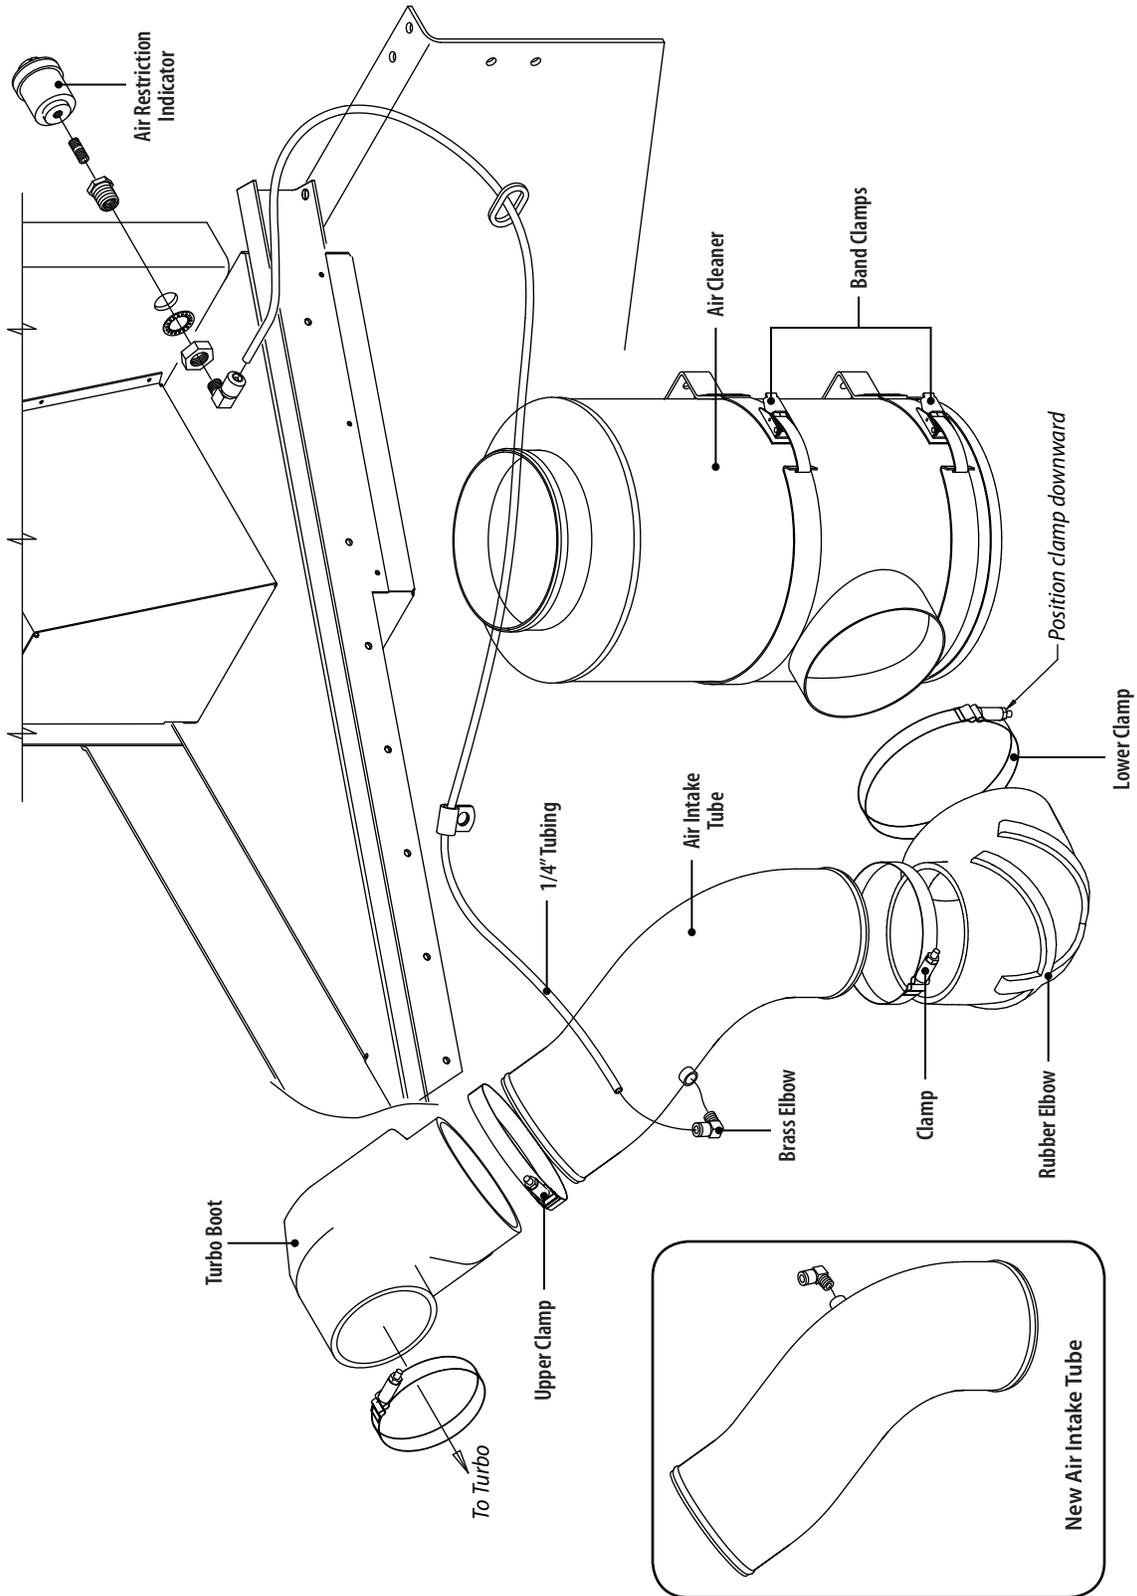
The elbow connecting the 1/4" air restriction indicator tube to the air intake tube may contact the stepwell.

**2** The air cleaner is located between the stepwell and the chassis frame rail. See diagram, page 2.

Replace the existing air intake tube with a new air intake tube which diverts the elbow away from the stepwell area.

- 6.1 Clean all loose sealant and contamination from the brass elbow.
- 6.2 Apply Teflon tape to threads and install in new air intake tube. Position brass elbow so that it points in general direction of engine hood opening when assembly is installed on bus.
- 6.3 Assemble new air intake tube and rubber elbow with clamp; do not tighten clamp.
