BLUE BIRD

You will find enclosed a copy of Service Bulletin S09PA regarding the battery disconnect switch cable routing on your 2005-09 model year Blue Bird "Vision" buses.

Battery Disconnect Switch

MODELS AFFECTED: All 2005-2009 BBCV Visions With Option 40142-01, Battery Disconnect Switch

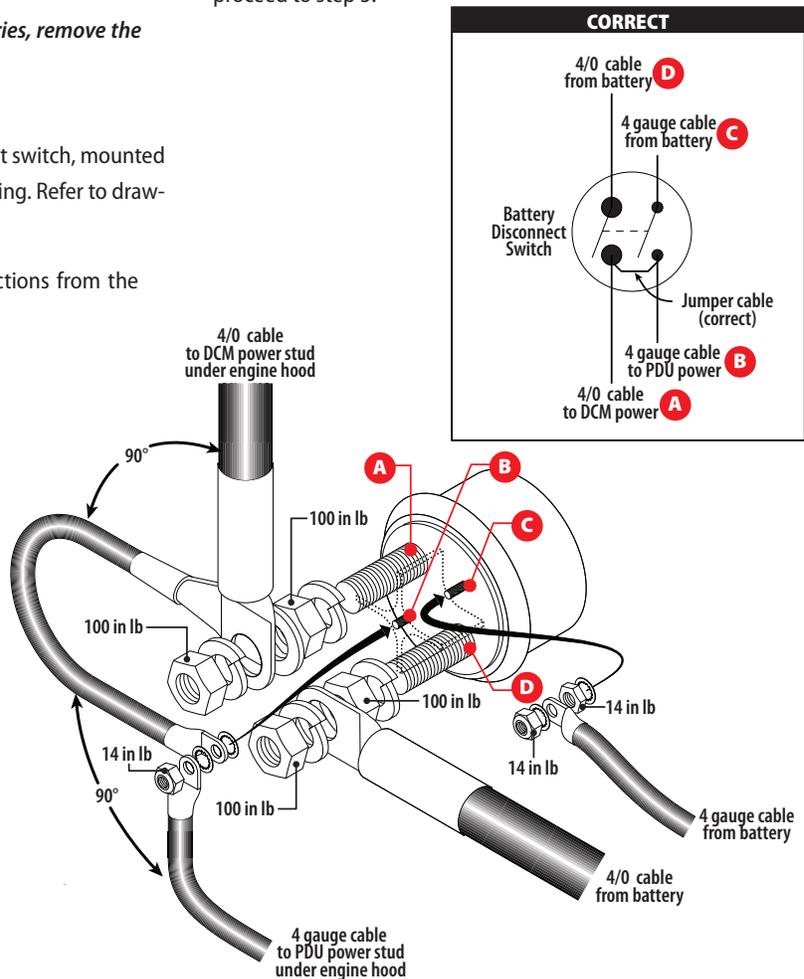
3 Locate the body of the battery disconnect switch, mounted to the outside of the battery compartment housing. Refer to drawings below, note the following:

- The switch assembly receives two connections from the battery box: A 4/0 cable connected to a 1/2" stud and a 4 gauge cable connected to a 10-32 stud. The jumper cable should not connect to either of these studs.
- The switch assembly has two other connections, both of which lead to the rear of the engine compartment: A 4/0 cable connects to a 1/2" stud on the switch and provides power to the DCM, and a 4-gauge cable connected to a 10-32 stud on the switch provides power to the PDU. These two switch terminals should be bridged by the jumper cable.

4 Referring to the illustrations below, inspect the battery disconnect switch jumper cable connections, to ensure that the jumper cable connects between the 4/0 cable and 4 gauge cables which lead to the engine compartment, and that neither end of the jumper cable connects to either of the cables which lead to the battery box.

5 Remove the jumper cable and connect it to the correct terminal studs as shown in the illustration. Tighten all ½" stud nuts to 100 in lb. Tighten all 10-32 stud nuts to 14 in lbs. Apply a corrosion protection such as red glyptal to all studs/terminal ends from which nuts were removed.
